# U.S. ENVIRONMENTAL PROTECTION AGENCY POLLUTION/SITUATION REPORT 2015 Gold King Mine Release SITREP

**Subject:** Situation Report #8

Gold King Mine Release San Juan County, CO

**Date:** 08/16/2015

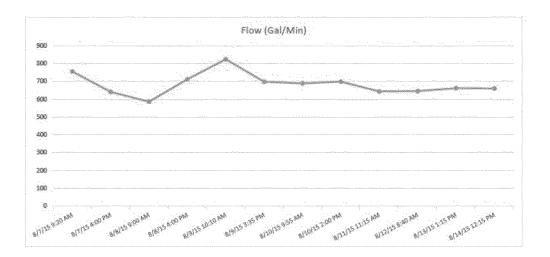
Flow from the mine through the morning of 8/14/2015 is shown in the following chart. The flow chart will be updated for the next SITREP. The treatment pond effluent pH on the afternoon of 8/13/2015 was 4.95.
